MEMORANDUM

TO: File DATE: October 27, 2009
FROM: Matt Wilson - MWH CC:
SUBJECT: Contract 4 – Summary Memo for of Rehabilitation Alternatives for CAM001

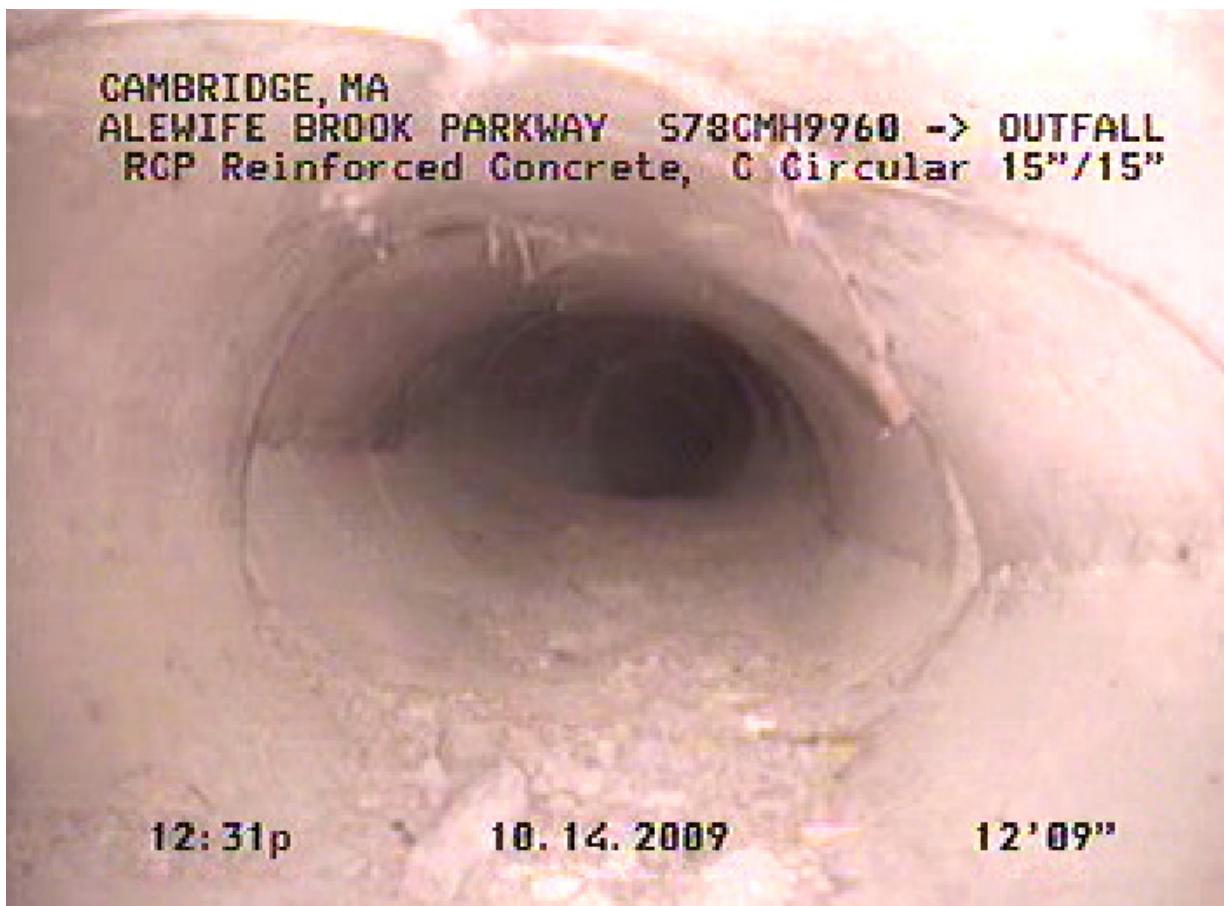
During development of construction plans for the installation of a floatables control baffle inside the existing CAM 001 regulator structure, defects in the existing CSO outfall were discovered. Photos taken during confined space entry indicated what appeared to be a localized defect at the CSO regulator exit. Subsequently, a CCTV inspection of the outfall was requested and upon review of the tape, more significant damage to the outfall pipe was observed. Approximately 23-ft of the total 48-ft length of the outfall pipe was observed to be VCP and the remaining 25-ft is RCP. A majority of the 23-ft VC section has experienced significant cracking and in many cases, 10-20% deformity. See Figure 1 below.

Figure 1: CCTV screen shot of CAM 001 defects

The existing outfall is 15" diameter. There are some sections of pipe that appear to be up to 20% deformed based on TV inspection, leaving approximately 12" of height available. Sliplining would be most practical utilizing short lengths of HDPE pipe that are fastened together with a chain wrench. Completed sections can be hydraulically pushed or winched further into the sewer until the entire pipe insertion is finished. However, pipe satisfying the inside diameter requirement is too large to slip through the existing deformed cross section. Standard sliplining was considered impractical due to the length of pipe involved and the necessity of working in the Brook and associated permitting challenges (similar to pipe bursting). The sliplining alternative was therefore rejected.

Excavation & replacement is the preferred rehabilitation option. An alternatives analysis follows.

Excavation & replacement is considered the most practical rehabilitation of the CAM 001 outfall due to ease of construction, i.e. similar work is proposed nearby, minimal environmental impacts, minimal traffic impacts, and cost. A portion of the work will take place in the 25-ft riverfront area buffer and an NOI will be required for work on DCR property.

Replacing the 23-ft defective section of the CAM 001 outfall involves work on a shallow pipe with approximately 4-ft of cover. It is off the Alewife Brook Parkway traveled way on the DCR grassed area. The proposed trenching would bisect a line midway between two existing trees and is outside of the drip line of both. The existing bituminous bike path crossing over the pipe alignment will require a bituminous patch after trenching is complete. Due to the shallow nature of the outfall, a final product with new RCP is desirable in order to limit the uncertainties associated with the structural strength of some trenchless solutions.

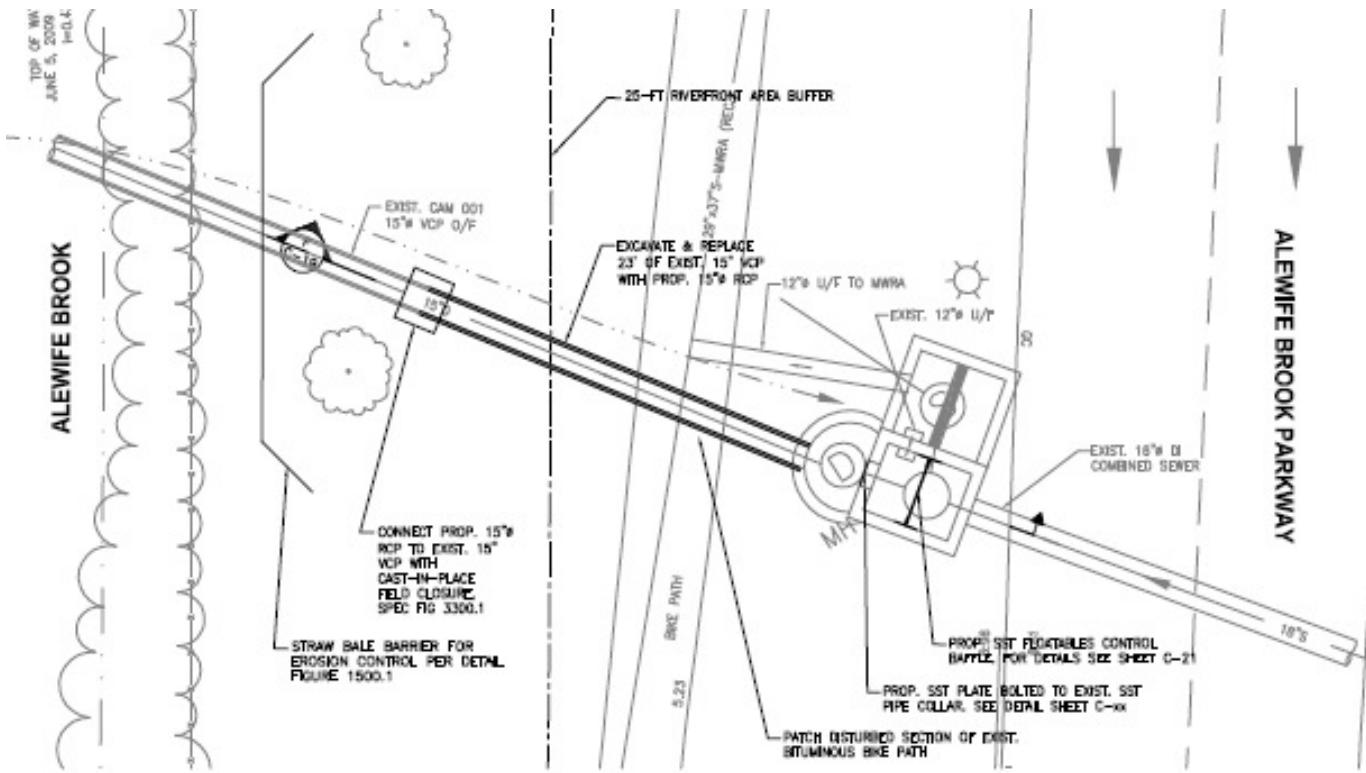
Figure 2: Proposed excavation & replacement improvements of CAM 001 outfall

See Figure 2 for proposed improvements at CAM 001.
