**City of Cambridge
Department of Public Works**

FIELD INSPECTION & PRE-DESIGN MEMORANDUM

CAM400 COMMON MANHOLE SEPARATION PROJECT

September 17, 2009

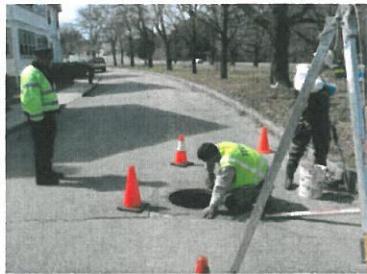
During the manhole inspections conducted on Seagrave Road, none of the common manhole separation plates were in place and dry weather flow was noted in the drain line of all manholes. Dye testing of buildings at 5-6 and 27-28 Seagrave Road confirmed illicit connections to the storm drain on Seagrave Road. Subsequent review of TV tapes identified 9-10 Seagrave Road as an additional illicit connection to the storm drain.

Looking southwest on Seagrave at S75SMH1515

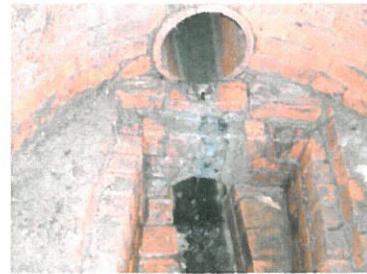
Figure 8 – Manhole S75COM1515 – Illicit Flow in Drain

Inlet sewer and inlet drain in S75COM1515
Shows drain flowing into sewer

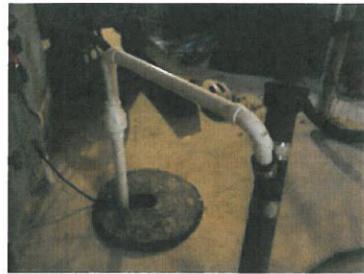
Figure 9 – Sump Pump Connection to Building Sewer

Example of sump pump hard piped to sanitary service,
easily removed and redirected to surface.

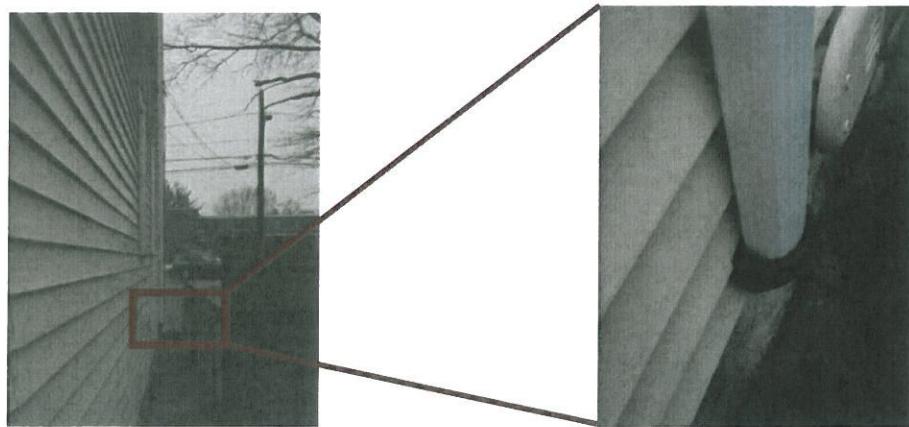
Figure 10 – Flat Roof Drain Connection to Building Sewer

Roof drain gutter, at 58 Madison Avenue, hard piped to sanitary service, easily redirected to surface

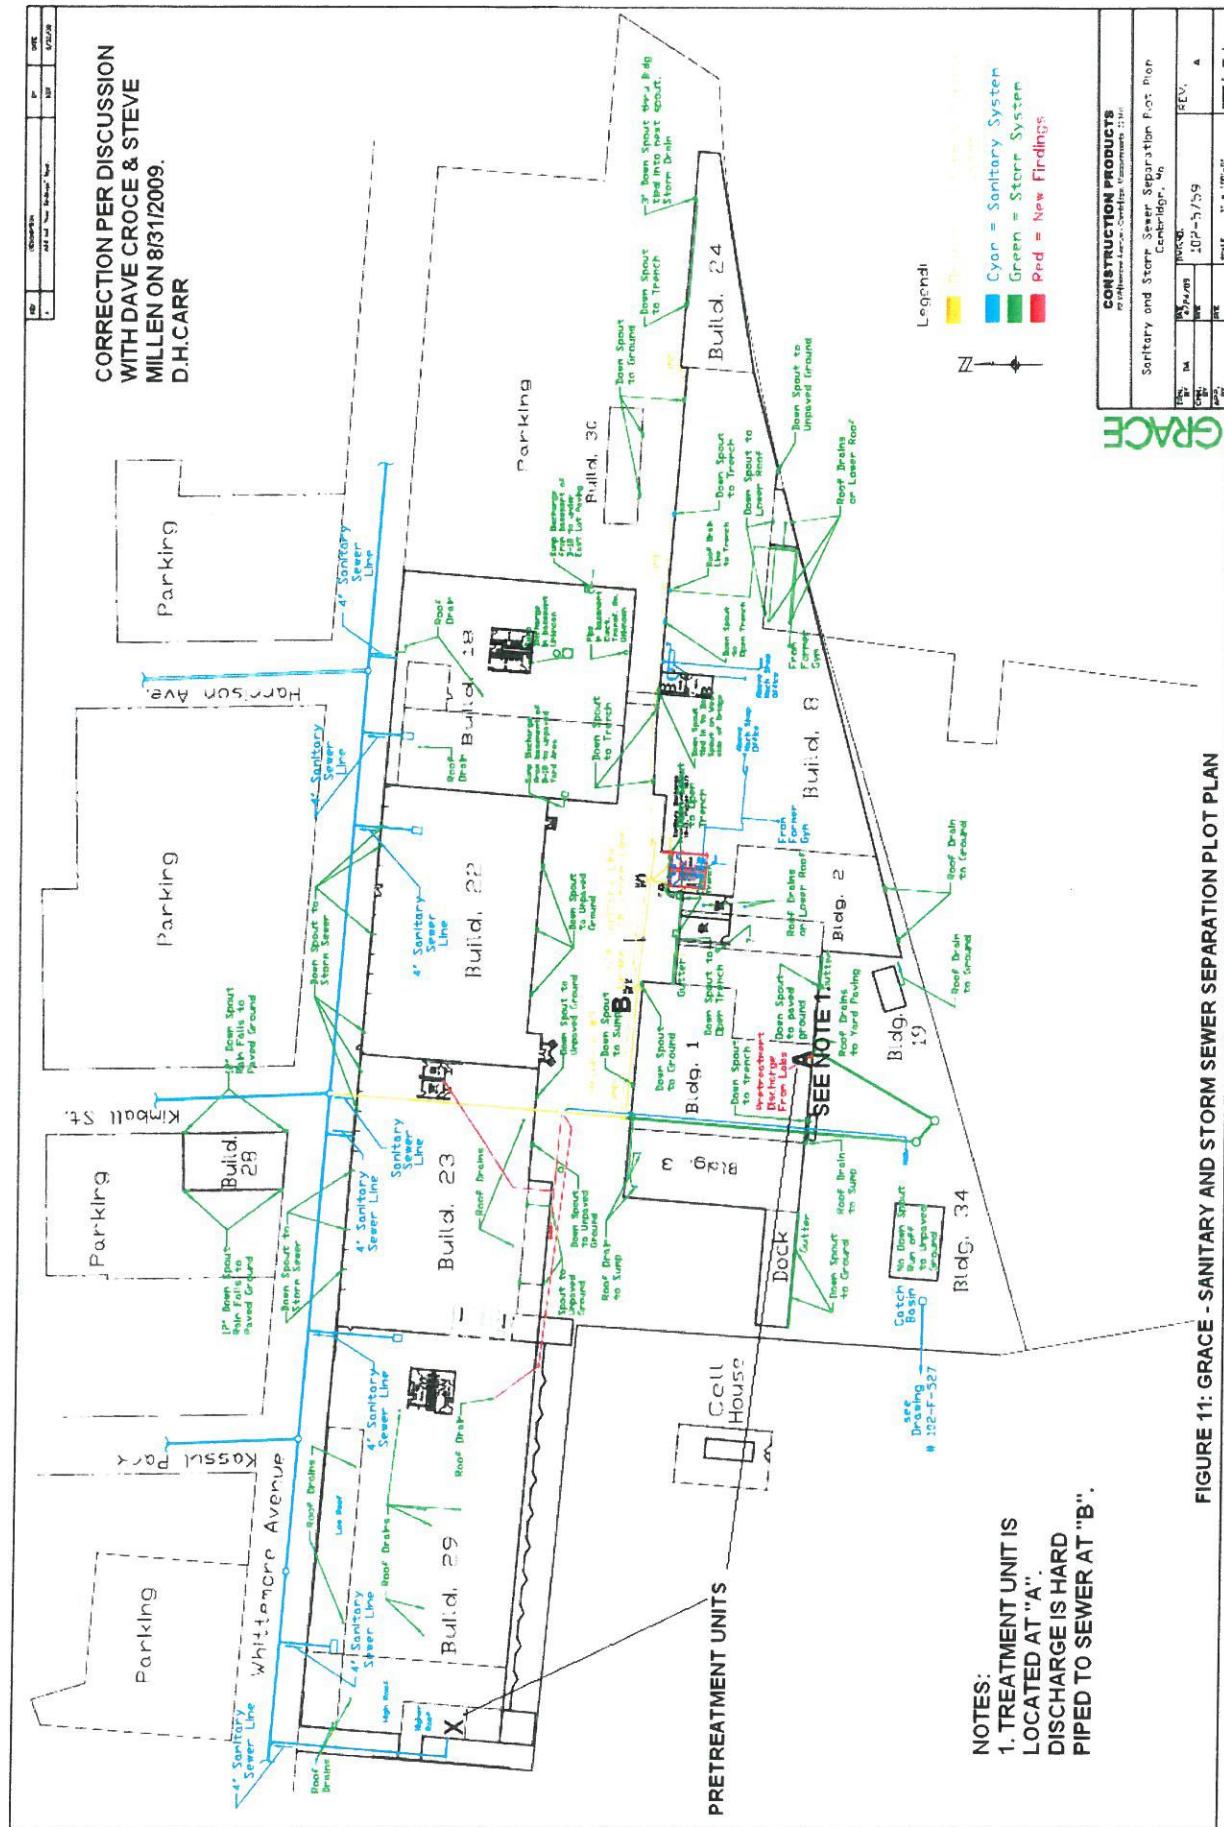
FIGURE 11: GRACE - SANITARY AND STORM SEWER SEPARATION PLOT PLAN

The Grace facilities have multiple sewer service connections and multiple drain service connections to the City's collection system. These connections are shown schematically on Figure 11. A two day inspection of the facilities generally provided visual confirmation of the layout as shown on Figure 11. Only limited dye tracing was performed to confirm connectivity of the system. It did appear that within the buildings, the process wastewater, sanitary wastewater and roof drainage are collected and

The connections to the City's system along Whittemore Ave. consist of eight sanitary sewer in-line connections and an unknown number of drain service connections. Along the City's easement through Grace's property, the connections consist of three sanitary and one drainage connection to manhole S75COM1900, one sanitary and one drainage in-line connection about 160 feet upstream of S75COM1900, one boiler blow-down connection to the manhole S75COM1905 (the pit), and one drain connection to manhole S75COM1910.

The task of matching the multiple locations of those service discharge points shown on Figure 11 with the connections shown on CCTV logs for the sewers and drains on Whittemore Avenue is a task that has yet to be done. An important observation from the CCTV inspections is that none of the service connections observed in the sewer or drain located directly beneath any of Grace owned buildings appeared to be active.
